| <p align="center"><b>Vojenský technický ústav, s.p.</b><br/>With the certified quality system according to ČSN EN ISO 9001</p> | | <p><b>Task/Order No.:</b><br/>25-19-5-93-3074/3595</p> <p><b>Test Report No:</b><br/>194300-048/2025</p> <p><b>Copy No.:</b> 1</p> <p><b>Pages:</b> 12</p> <p><b>Annexes:</b> -</p> |
| <p align="center"><b>TEST REPORT</b><br/><b>ENVIRONMENTAL TESTING</b></p> | | |
| <p><b>Identification of Equipment under test:</b><br/><b>Type:</b><br/><b>Serial Number:</b><br/><b>Manufacturer:</b></p> | | <p>MTU-1A2 Pan Tilt Positioner<br/>MTU-1A2<br/>MU0109, MU0101<br/>EVPÚ Defence a.s.<br/>Jaktáře 1781, 686 01 Uherské Hradiště, Česká republika</p> |

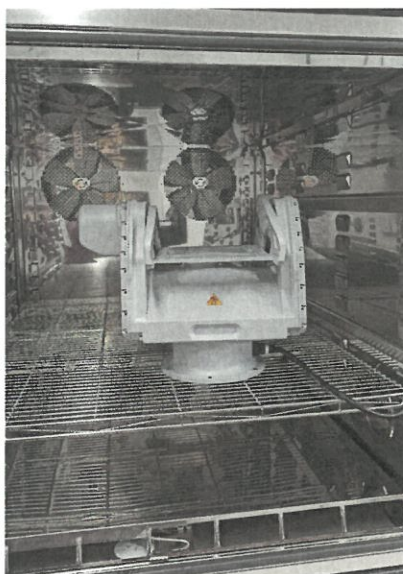
Figure 2 Placement of tested devices in the climate chamber ClimeEvent C/1500/70a/5
