| <p align="center"><b>TEST REPORT</b><br/><b>ENVIRONMENTAL TESTING</b></p> | | |
| <b>Identification of Equipment under test:</b> | | MTU-1A2 Pan Tilt Positioner |
| <b>Test method:</b> <sup>1)</sup> | | MIL STD 810G method 521.4 |

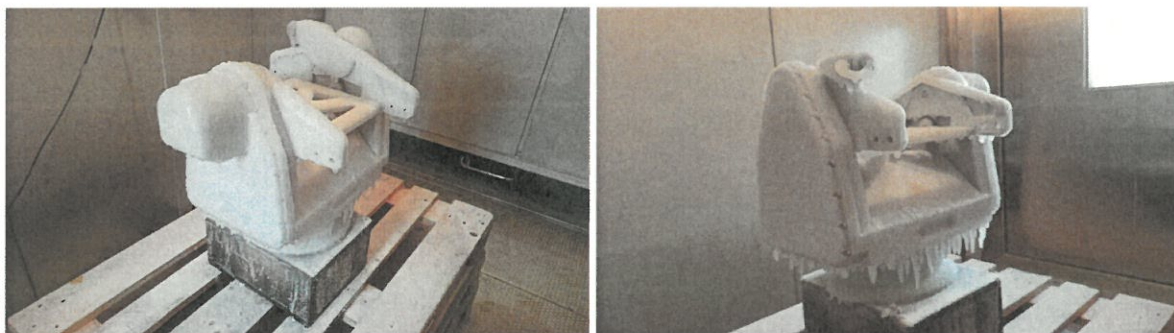
The temperature in the climate chamber was reduced to -10 °C. Spraying with distilled water was carried out at intervals of 20 minutes from each side of the EUT until the desired ice layer was formed. Ice build-up occurred from drizzle falling on the EUT, whose temperature was below freezing.

Figure 4 Tested device after the required ice layer is formed

MTU-1A2 Pan Tilt Positioner (production number: MU0109) was tested by icing/freezing rain without visual damage and the tested function (paragraph 2.3) was functional.

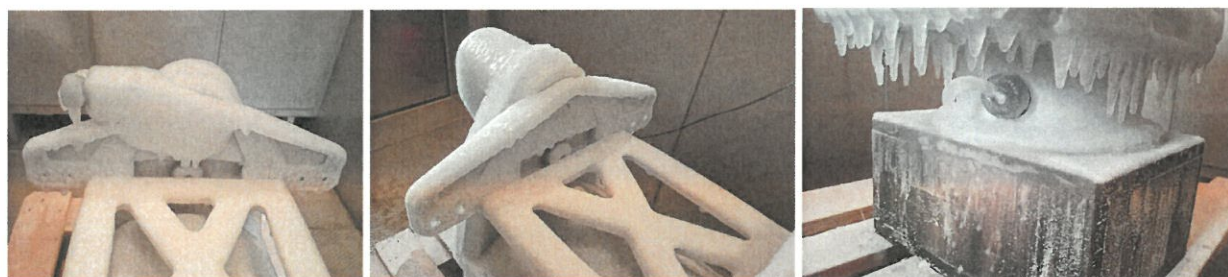
Figure 5 Detail of the EUT with a layer of ice
